# Report on the fieldwork at the sites of the Dutch submarines O16 and K-XVII

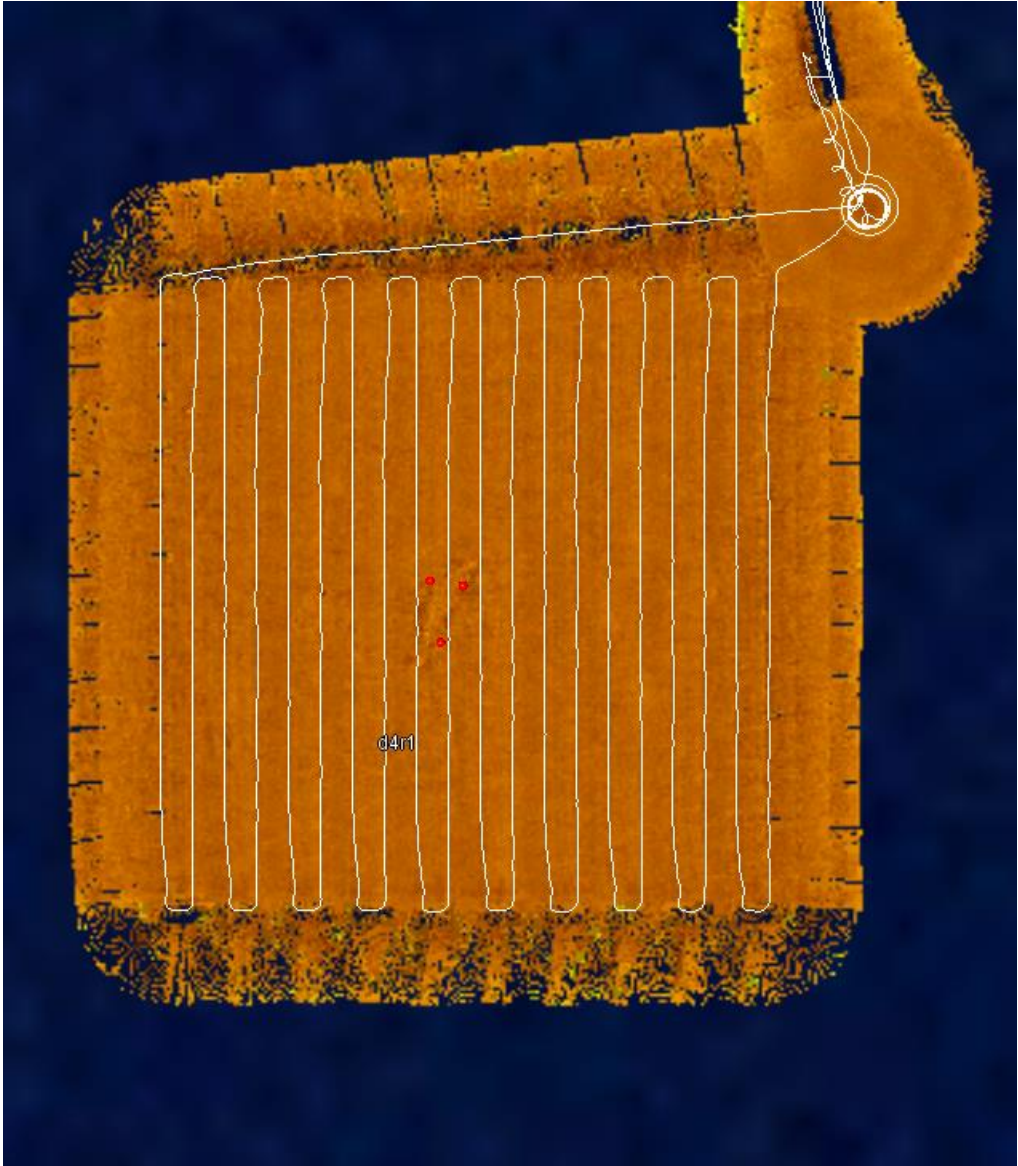
Figure 5: Side scan sonar mosaic of the K-XVII wreck site made with the Remus sonar.

The last information the team has had from a diver was that he dived the site on the 18<sup>th</sup> of May 2018. At that time, according to his report, at least large parts of the wreck were still visible on the site. When surveying the site with the REMUS it became immediately clear that the site was now almost completely salvaged. In a 'box' of 500 by 500 m, there is a small seabed area of approximately 90 metres of length that has been disturbed.

Traces of salvaging are visible, including anchor dragging. Here and there, small pieces of deformed wreck material were detected, not more than a few metres long. The image was clear enough to conclude that the wreck has been salvaged. Due to the fact that the imagery was already at its best, it was decided by the team that there was nothing to gain with further research.

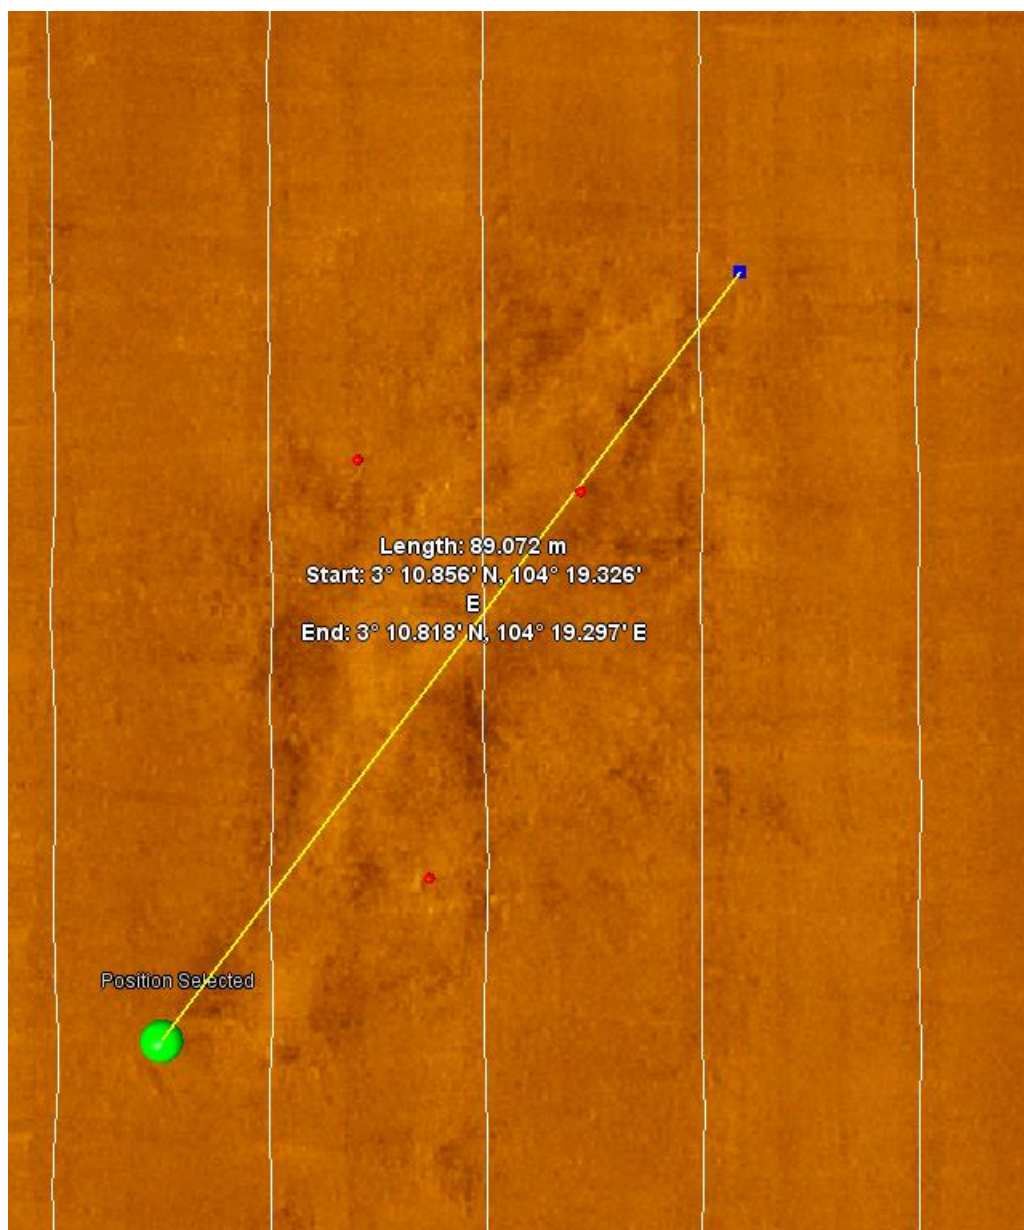
Figure 6: Sonar detail of the K-XVII wreck site. Hardly any wreck material is left onsite.
