# Stability of beam trawlers

RC22C003-1999-rev04

# Abstract

*Establish the risks of capsizing and sinking induced by asymmetrical loads, for fishing vessels within the Dutch beam trawler fleet.*

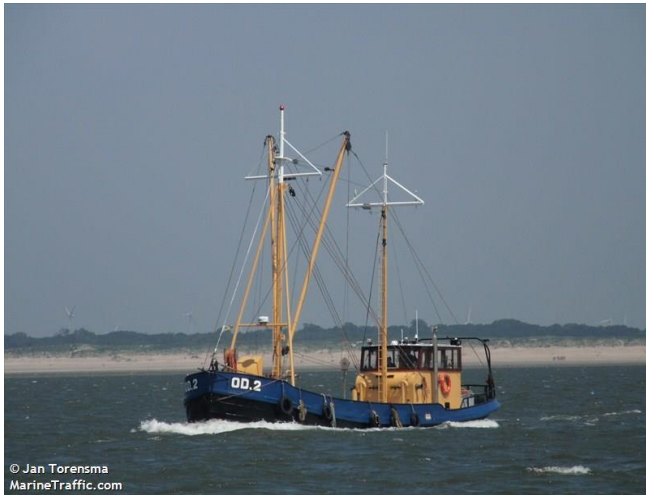
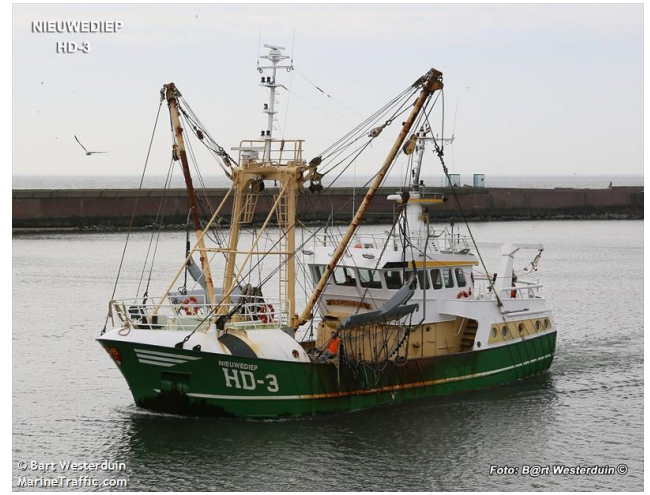
Figure 9: Picture of OD-2 Neeltje and HD-3 Nieuwe Diep (MarineTraffic.com)

Parameter	OD-2 Neeltje	HD-3 Nieuwe Diep
Year of construction	1917	2002
Length over All	22.21 m	23.99 m
Breadth moulded	4.00 m	7.00 m
Draught	1.60 m	3.80 m
Gross Tonnage	34 GT	160 GT

Table 5: Main particulars of OD-2 Neeltje and HD-3 Nieuwe Diep indicating the large variation in beam trawler dimensions

and Figure 9 show the main particulars of these vessels and an overview respectively.

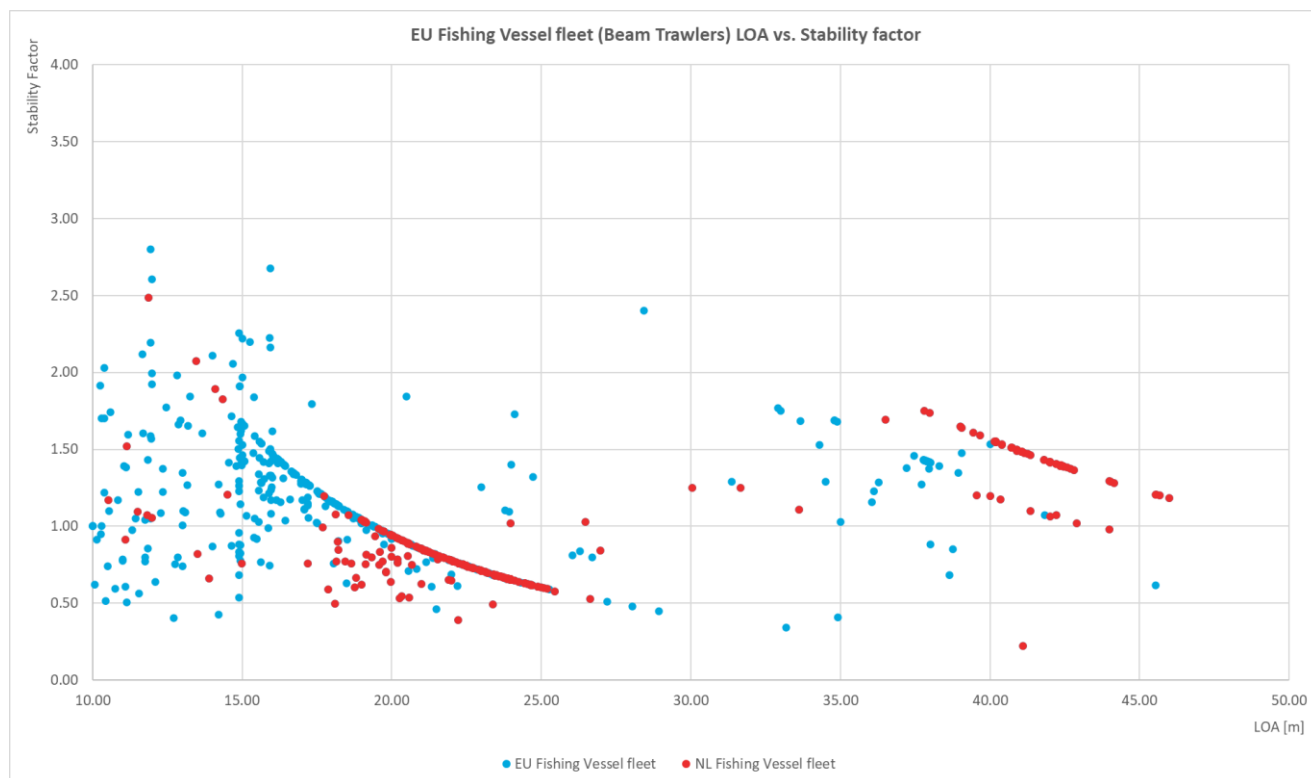
To identify the *stability factor* (introduced in chapter 4.1.2.1), and thereby the possible influence on the minimum applicable stability criteria, the stability factor is calculated for every vessel, and is plotted against LOA. See Figure 10.

Figure 10: Length over All plotted against stability factor for EU Beam Trawlers

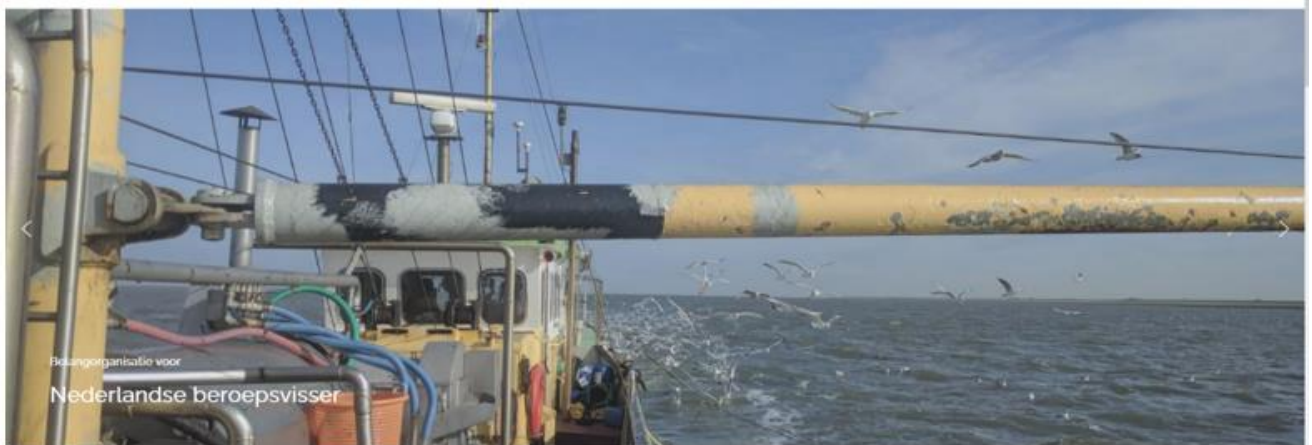
During interviews with inspectors of ILT and designers it became clear that derricks are regularly lengthened without updating the stability booklet. An example was found on the internet, showing a beam trawler with a clearly recently lengthened derrick.

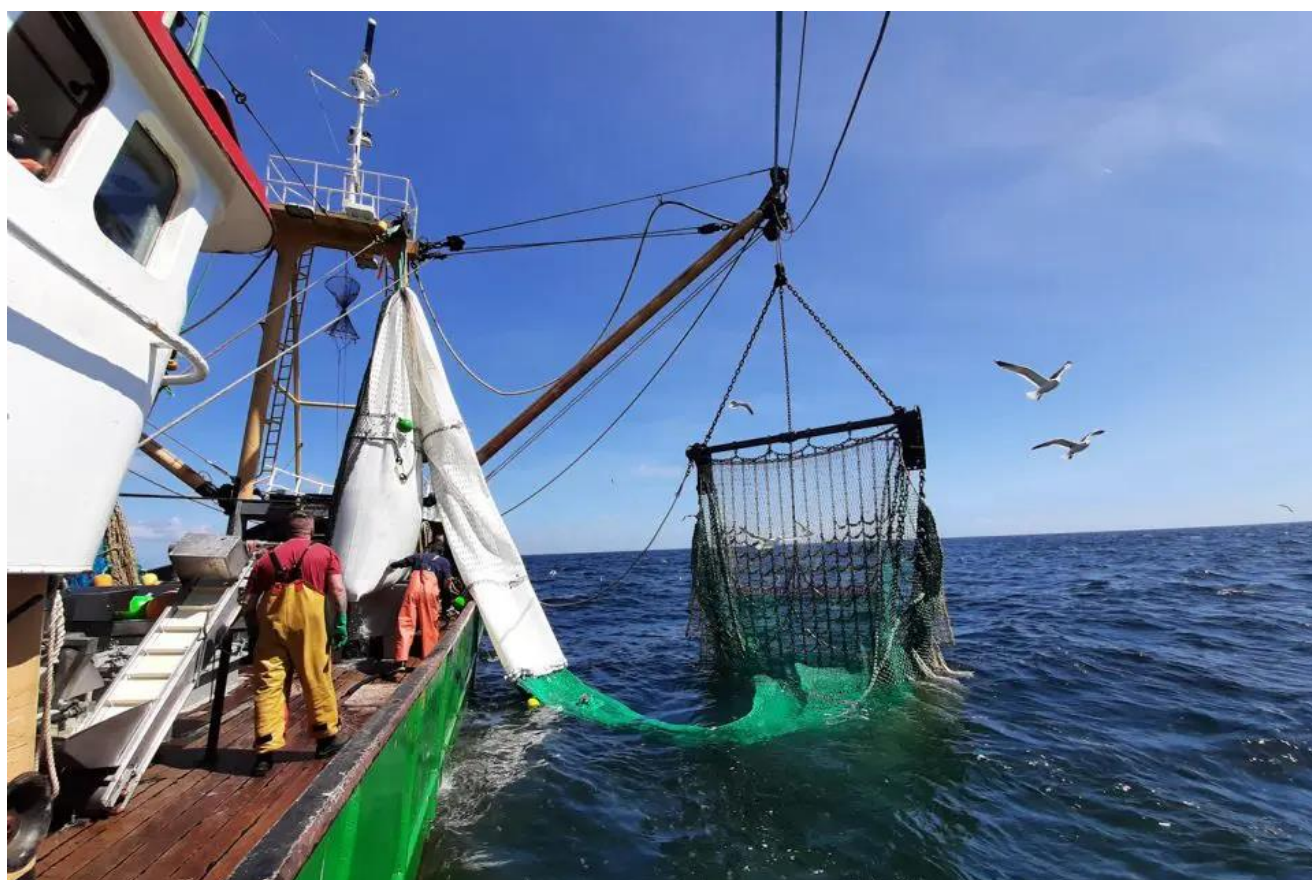
Figure 13: Hauling the cod-end of a net (picture source 'Globalseafood.org')

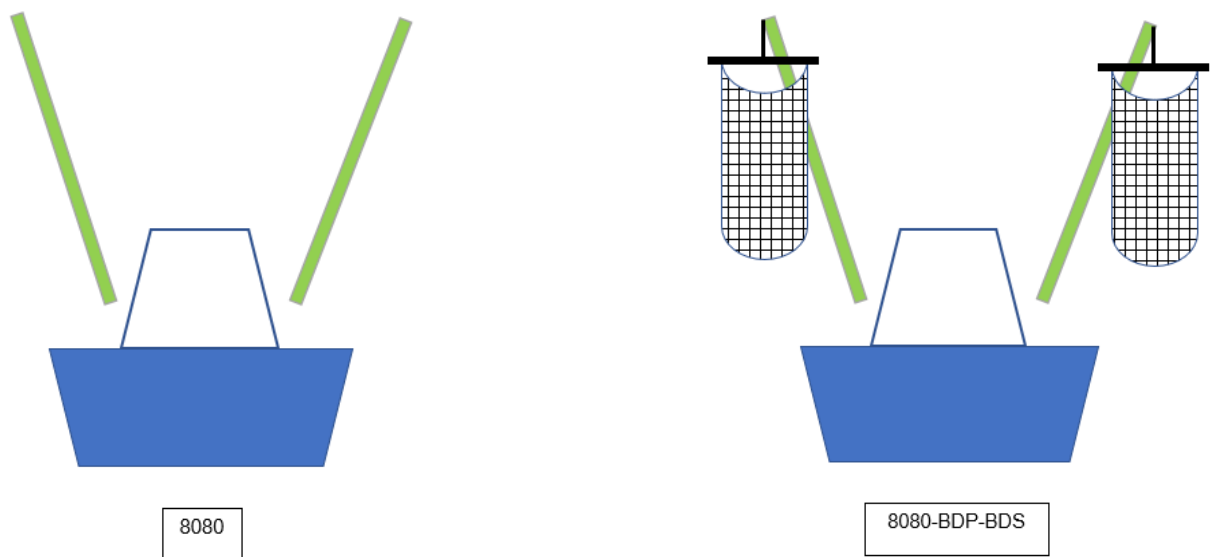
To determine the set of conditions, that could be used in the calculations of the remaining heeling moment for each vessel, a risk rating matrix was made with combinations of internal and external factors, the 'hard factors' as mentioned in chapter 9.1.1. These factors were used to calculate the stability of all vessels included in the investigation, as can be seen in chapter 8. Examples of observed fishing conditions, with their codes, are given in Figure 24 and Figure 25. Condition 8080 is the basic condition, 8080-BDP-BDS is the basic condition with nets hoisted from deck, suspended from the derricks.

Figure 24: Combined situations for fishing conditions with codes 8080: Derricks fully topped in transit position and 8080-BDP-BDS: Same situation, with fishing gear hoisted free from deck

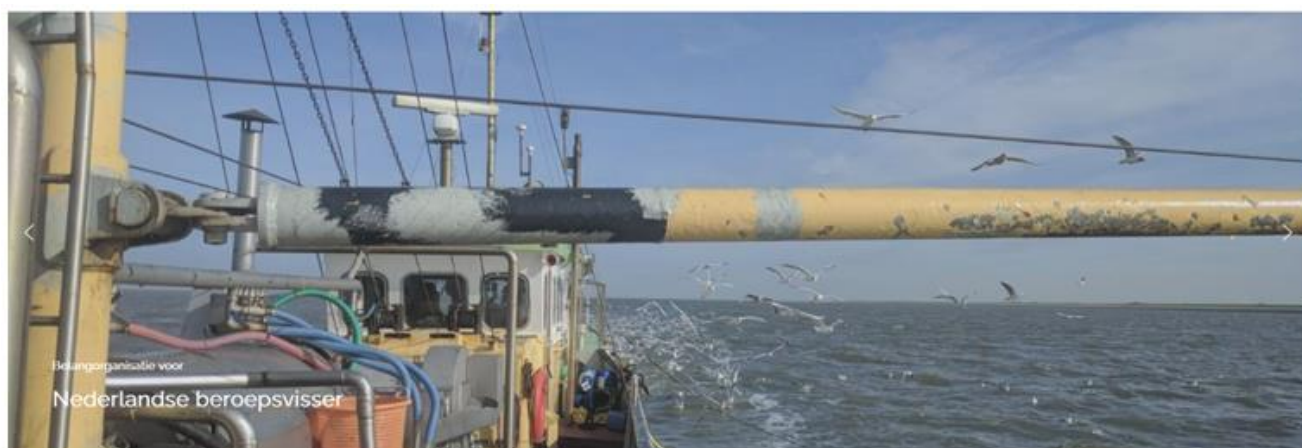
When a fishing gear is changed, the derricks are sometimes lengthened. An example is given in the picture below. Not always the stability information is updated for the derricks. Also, the effect of the longer derricks on the fishing conditions is not considered at all. Fishing conditions are not part of the stability information available to the master in the stability booklet.

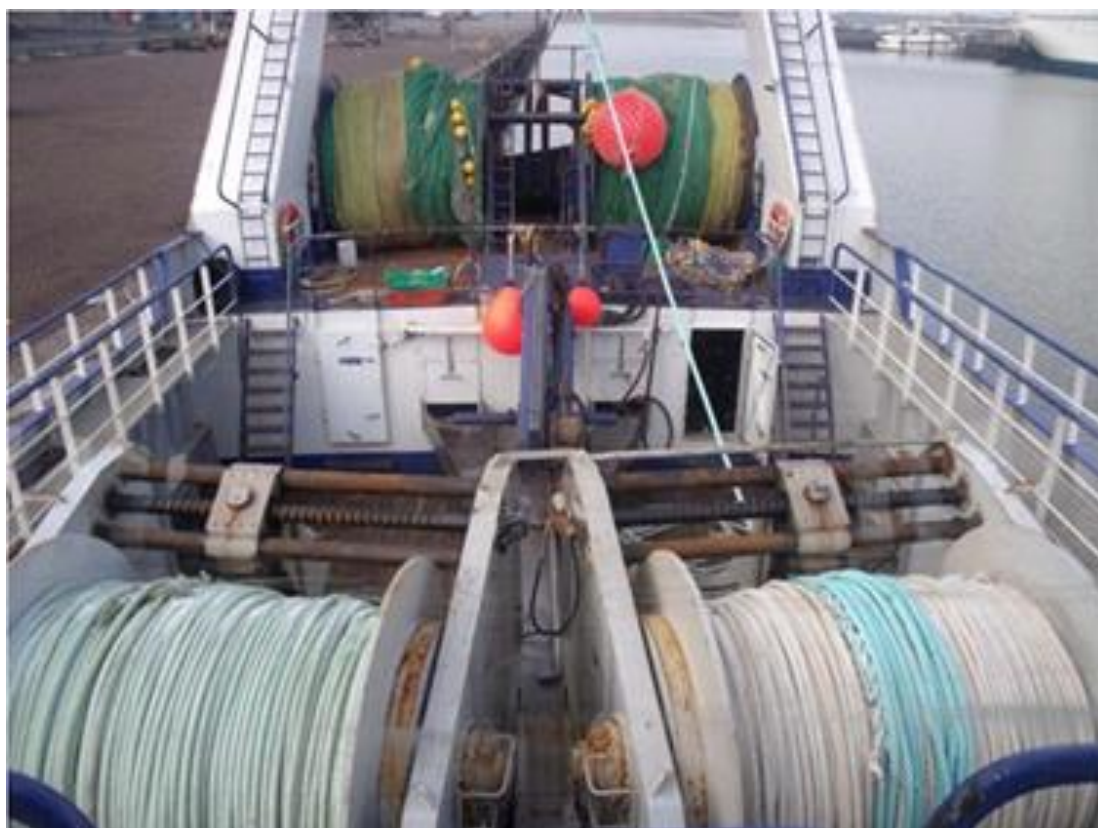
Often a combination of two fishing methods is used on a beam trawler: beam trawling and stern trawling (e.g. Twin rigging, Flyshooting) are alternated. When the vessel is beam trawling, the stern trawl gear is stored on net drums on the aftship, (Figure 33) or left ashore. The storage of the stern trawl gear is a topic mentioned in the stability booklet: For most vessels this gear must be removed when beam trawling and in some cases even the net drums have to be removed. This is not always done. Report on the capsizing and sinking of fishing vessels (Dutch Safety Board, 2021).

Figure 33: Stern trawl gear on the net drums

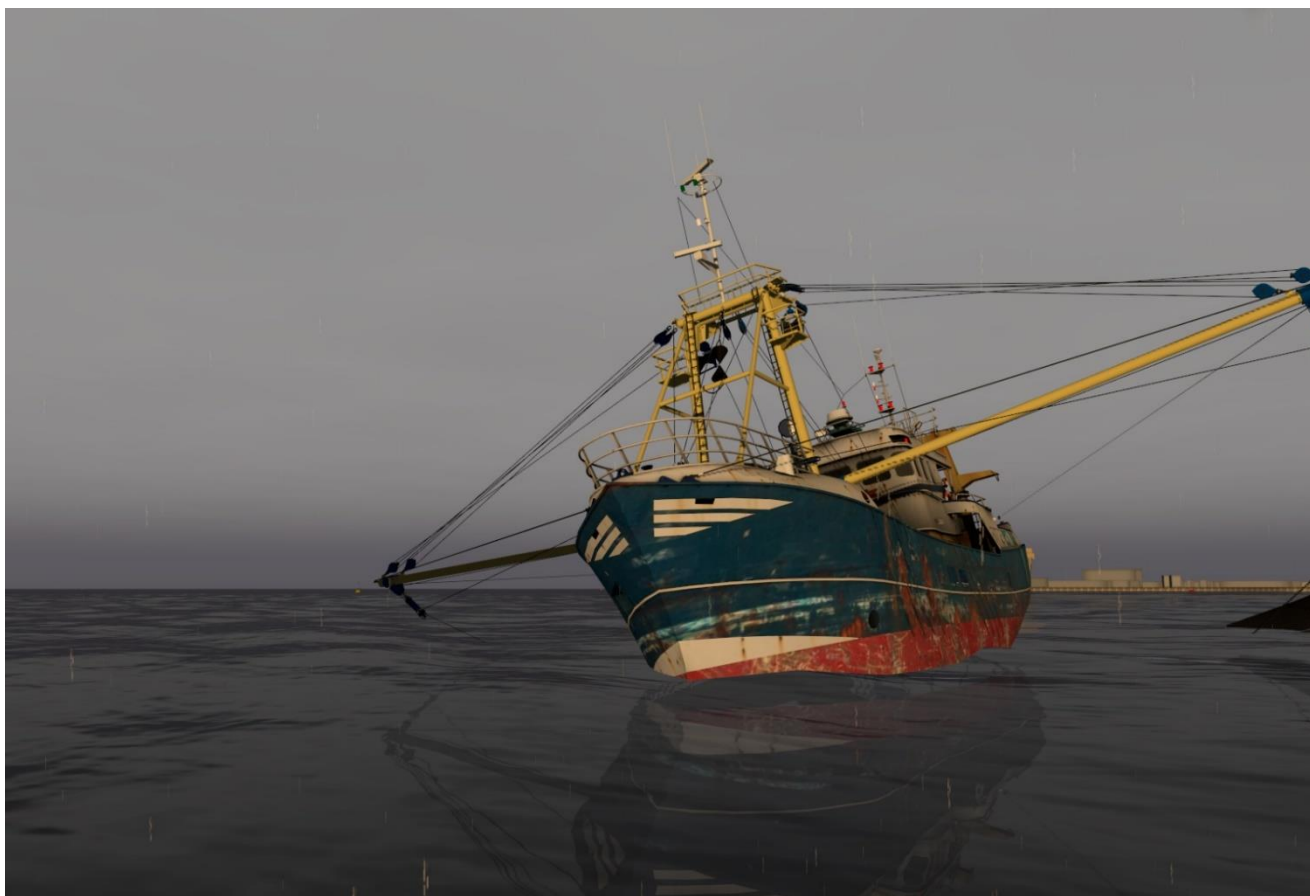
At this moment there is no bridge simulator that is able to fully show the effects of the fishing operations. However, MARIN is developing a bridge simulator, in which fishing conditions can be simulated, including the effects of changing derrick positions. Figure 34 shows a screenshot of the simulator.

Figure 34: Screenshot of the MARIN-simulator
