**TNO report**

**TNO 2016 R10735**

**Investigation into a Periodic Technical  
Inspection test method to check for presence  
and proper functioning of Diesel Particulate  
Filters in light-duty diesel vehicles**

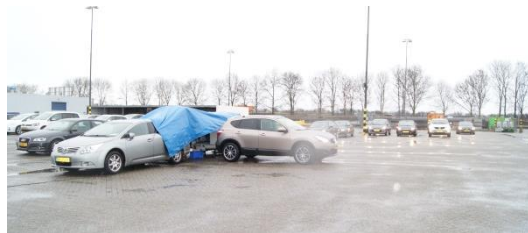
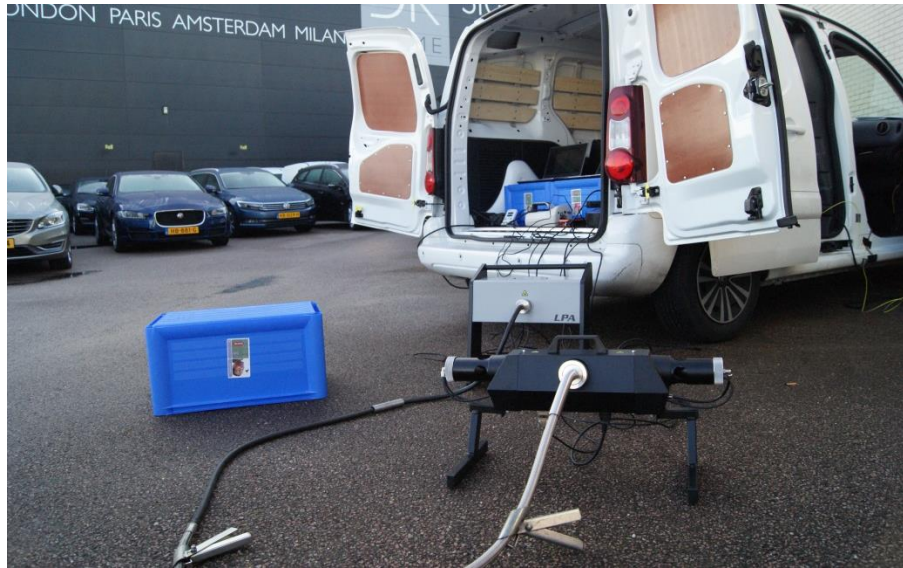
Figure 3 The measurements were carried out on-site at various lease companies and car shops using a 'mobile laboratory'.

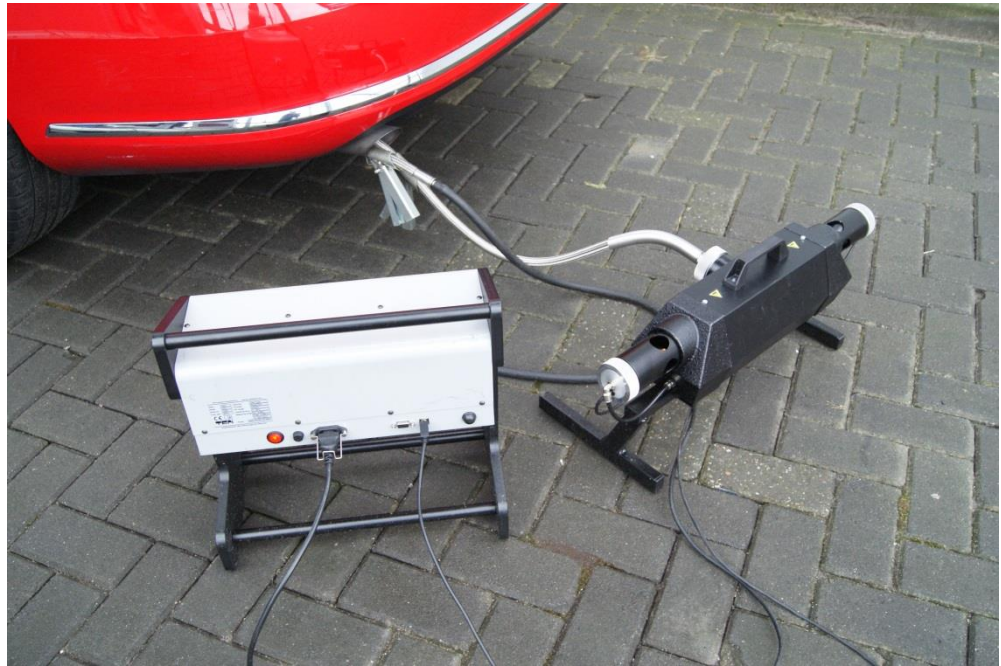
Figure 4 Opacity was measured using two types of opacity or smoke meters. The conventional EDA2 (right), and the modern, more accurate LPA (left). Both smoke meters are manufactured by TEN Automotive Equipment. As the picture shows, the in-line opacity meters were inserted into the exhaust pipe simultaneously.

TNO performed opacity measurements in free acceleration tests using two types of opacity meters or smoke meters, the TEN EDA2 and the TEN LPA (Figure 4). The particle number (PN) measurements were performed at idle engine speed using the TSI 3007, a handheld Condensation Particle Counter (CPC, Figure 5, Figure 6)

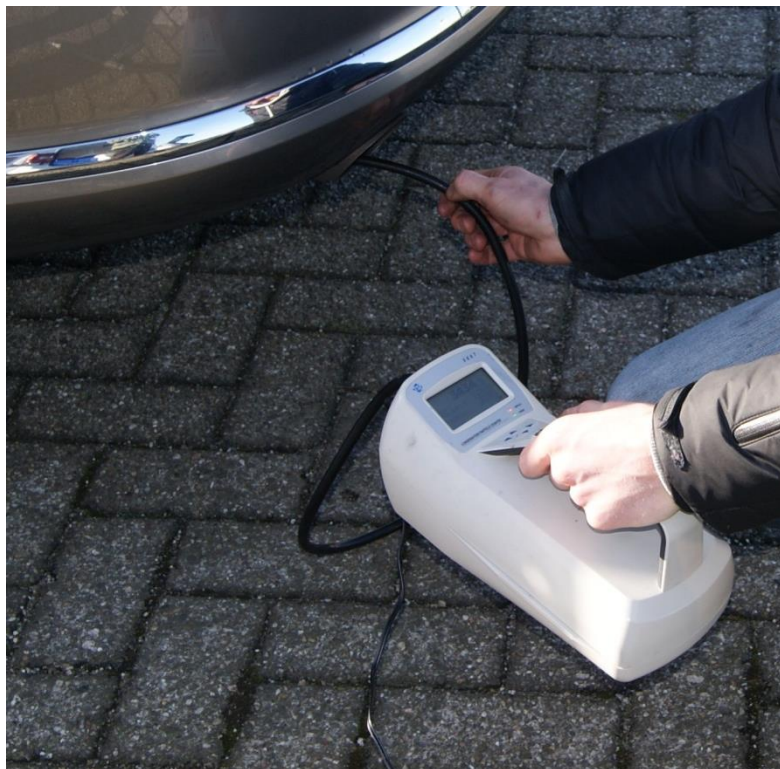
Figure 5 The particle number (PN) measurements were performed using the TSI 3007, a handheld Condensation Particle Counter (CPC). A sample hose, connected to the 3007, was kept in the exhaust flow with the engine running at idle engine speed.

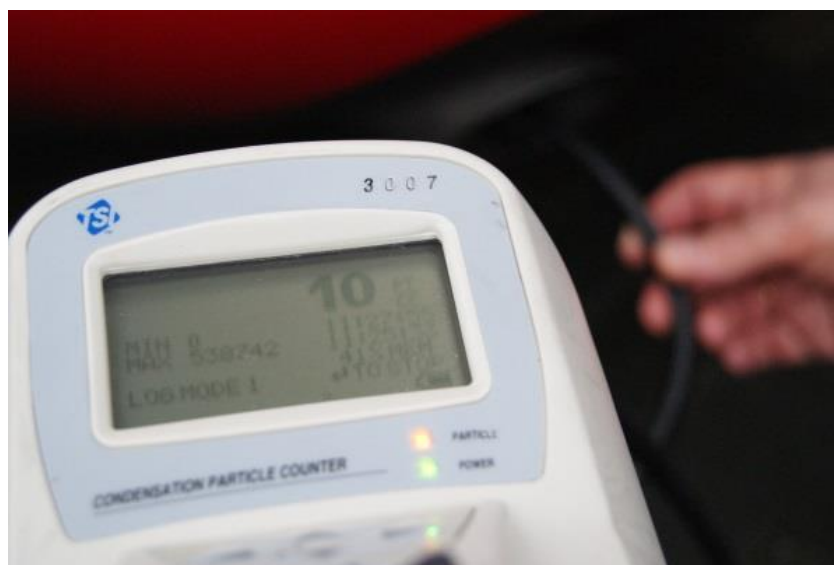
Figure 6 The sample hose was kept in the exhaust pipe until the read-out stabilized.

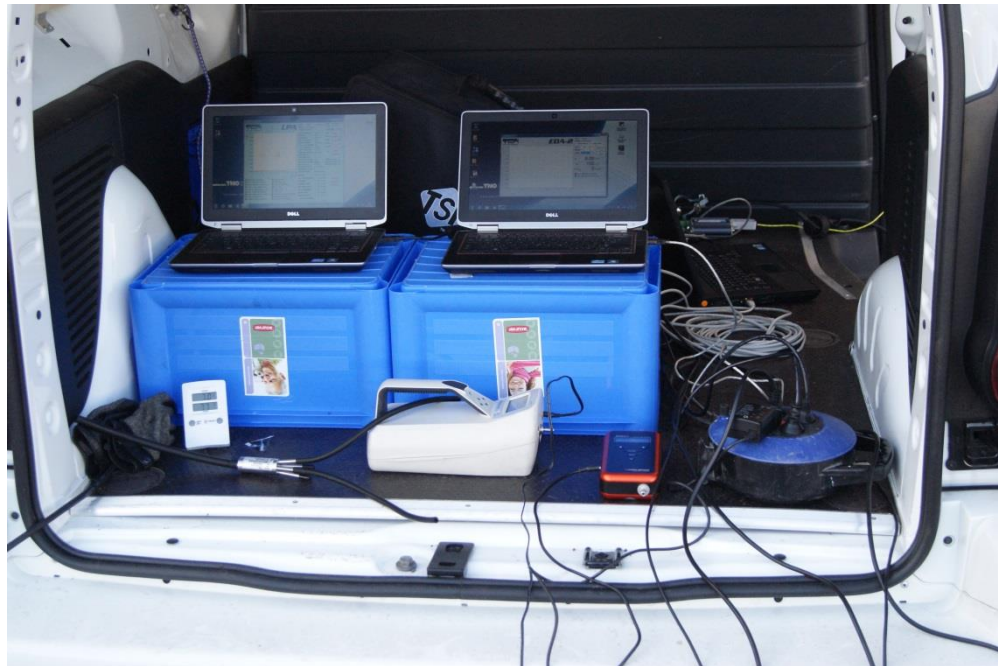
Figure 7 The smoke meters were connected to a laptop and data was logged using dedicated software. The TSI 3007 logs data internally, and test data was retrieved from the device by connecting it to a laptop at the end of a measurement day.

The smoke meters were connected to a laptop and data was logged using dedicated software. The TSI 3007 logs data internally, and test data was retrieved from the device by connecting it to a laptop at the end of a measurement day.

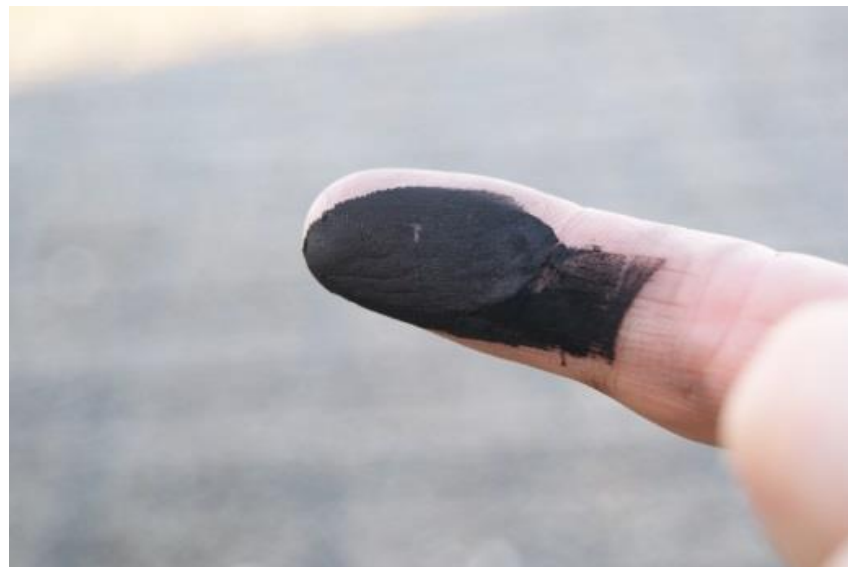
Figure 8 Example of two tailpipe swipe tests resulting in a deep black finger, scoring 3.

The results were categorized into four groups or scores: clean or no darkening (0), grey (1), black (2) and deep black (3). Clean tailpipes generally show no soot at all and leave fingers absolutely clean, indicating a well-functioning DPF. In case of heavily soiled tailpipes, a black, sticky and greasy layer of soot can be found. This black soot may indicate a malfunctioning or removed DPF.

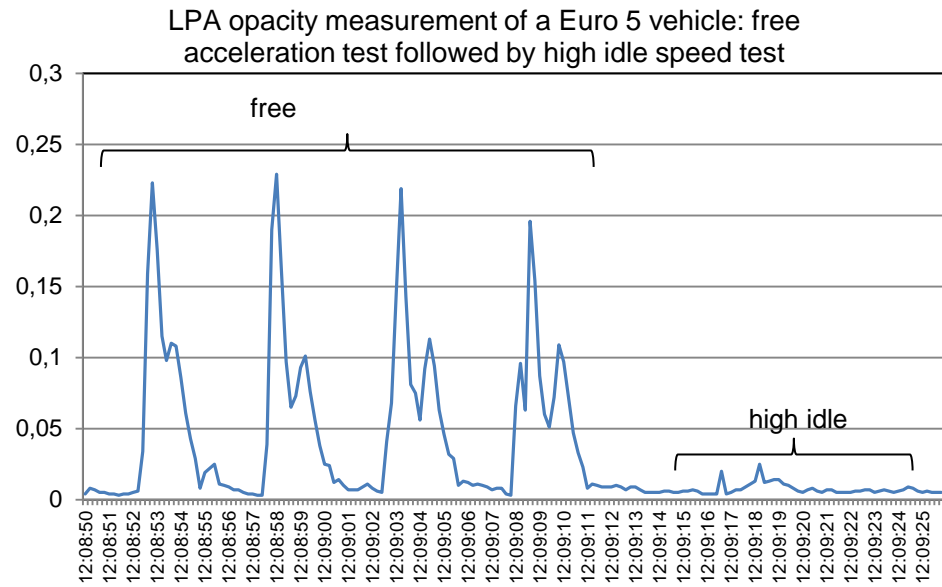
Figure 12 High idle speed test on a Euro 5 vehicle, directly following a free acceleration test on the same vehicle. In a high idle speed test, engine speed was kept at approximately 2500 rpm for 10 seconds.

Smoke emissions during high idle speed tests are generally lower than peak emissions during free acceleration tests, as Figure 12 clearly shows. For the vehicle at hand, smoke emissions during high idle testing are approximately 0,005 – 0,007 m<sup>-1</sup>; two peaks occur at 0,02 and 0,025 m<sup>-1</sup> (Figure 13).

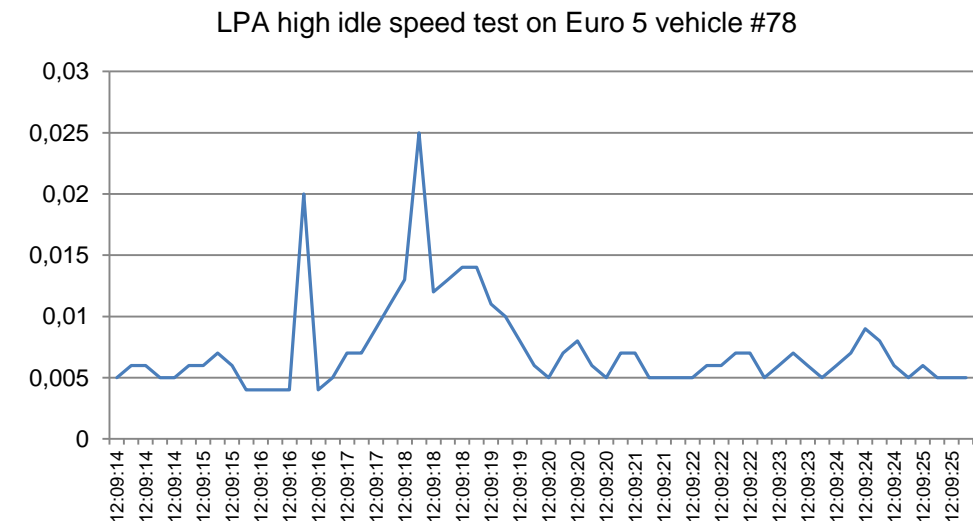
Figure 13 Zoom-in on the high idle test of Figure 12, showing emissions of approximately 0,005 – 0,007 with two peaks of 0,02 and 0,025 m<sup>-1</sup>.

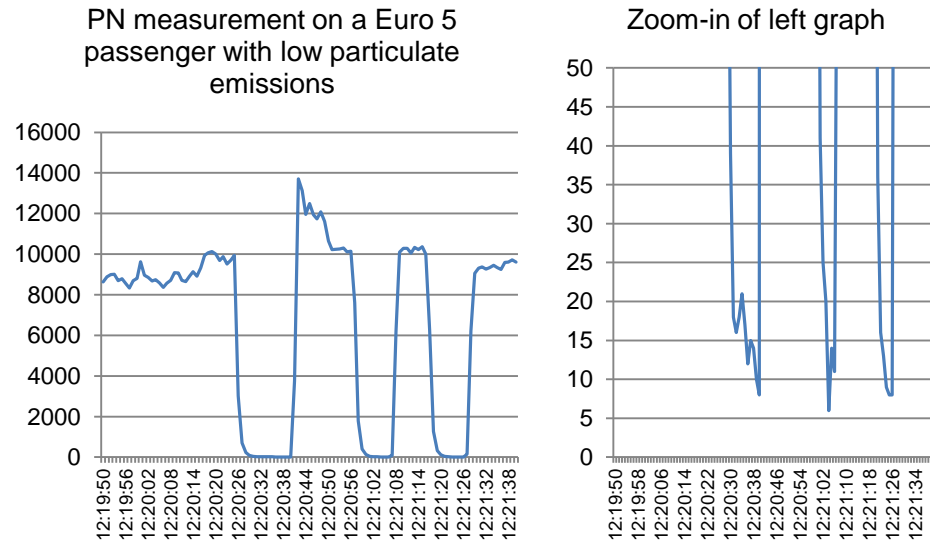
Figure 15 PN measurement on a Euro 5 car showing low particulate emissions. The graph shows that the ambient concentration was around 9,000 to 10,000 particles per  $\text{cm}^3$ . The three minima unmistakably represent the tailpipe measurements. Zooming in on the left picture shows the particulate emissions are as low as 6 to 8 particles per  $\text{cm}^3$ .

Figure 15 is a typical example of a PN measurement on a low-emission vehicle. As can be seen in the figure, the PN counter first reports a background concentration of around 9,000 particles per  $\text{cm}^3$ . Upon insertion of the sample hose, the number of particles starts to drop significantly. As little as 6 to 8 particles per  $\text{cm}^3$  were found.

As the next chapter will show, this kind of results was found frequently during the measurement series. A modern diesel car equipped with a well-functioning diesel particulate filter is capable of reducing the particulate emissions to practically zero. The number of particles in the car's exhaust in such cases is lower than the number of particles in the outside air.

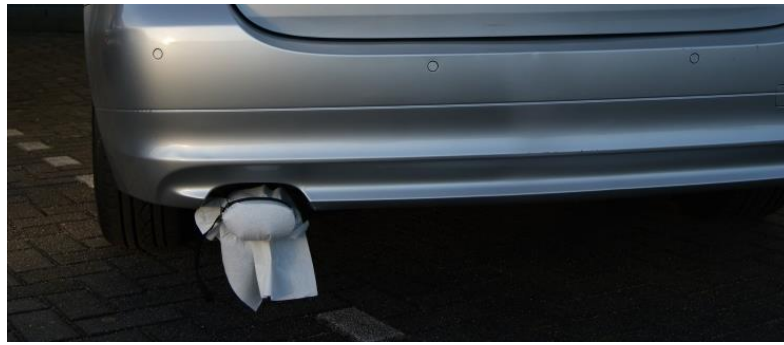
Figure 16 In the tissue filter test, a tissue was attached to the end of the exhaust pipe after which the engine was let running at idle speed for three minutes. Cars showing elevated emissions in previous tests were selected for the TFT.

Vehicles scoring 3 on the tailpipe swipe test and showing high opacity values and/or high PN emissions were selected for a tissue filter test. A tissue was attached to the end of the exhaust pipe, as can be seen in Figure 16, after which the engine was let running at idle speed for three minutes.

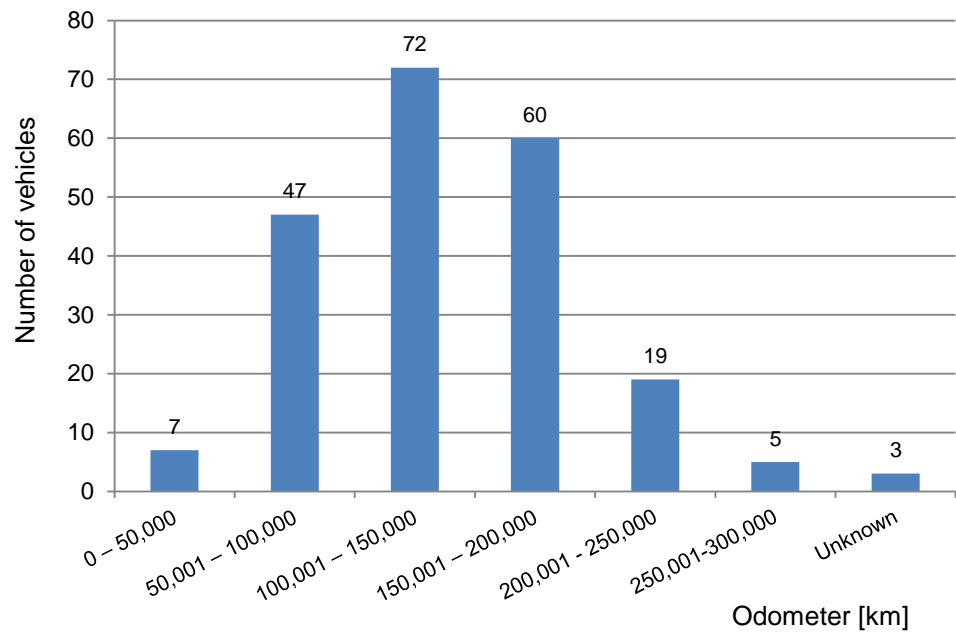
Figure 18 Odometer reading of the tested vehicles.

Figure 18 and Figure 19 show information on the odometer readings and age of the 213 tested vehicles. The group of tested vehicles covers a wide range of vehicle ages and mileages. 179 vehicles were ex-lease diesel cars or LCV's, i.e. cars that were mainly used for business use. Lease cars in general drive larger distances in shorter periods of time and are well-maintained. The test set therefore is not per se representative for the total Dutch diesel car fleet.

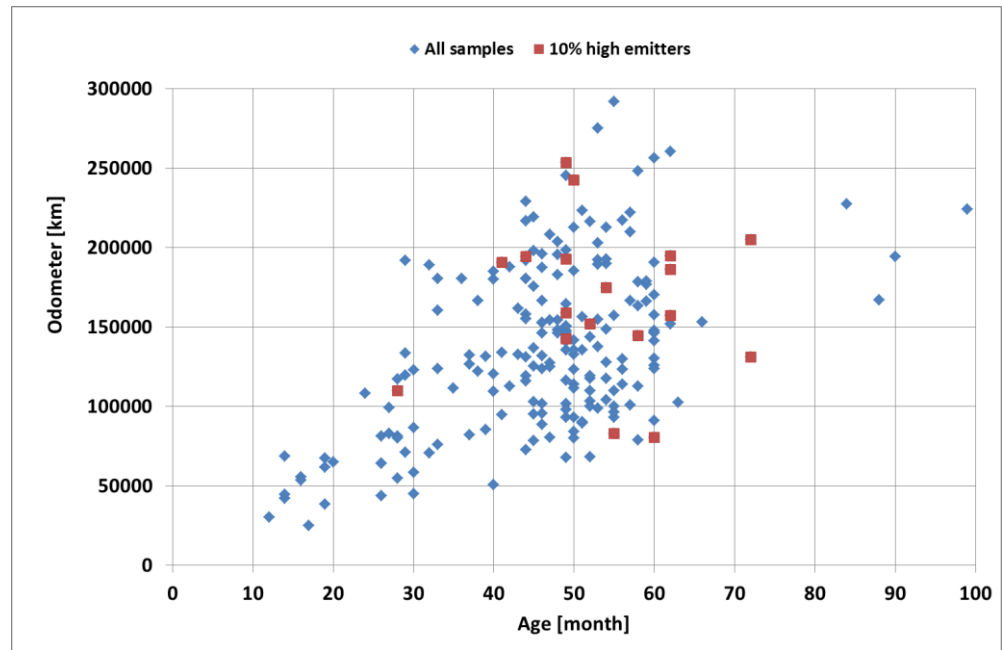
Figure 19 Age and odometer readings of the tested vehicles.

In Figure 19, the so-called 10% high-emitters are shown in red. Based on a Particulate Number (PN) emission of more than  $250,000 \text{ \#/cm}^3$ , the 10% 'highest-PN vehicles' were identified. As can be seen, most of the vehicles with high PN numbers are 4 to 5 years old, with a mileage between 130,000 and 190,000 km.

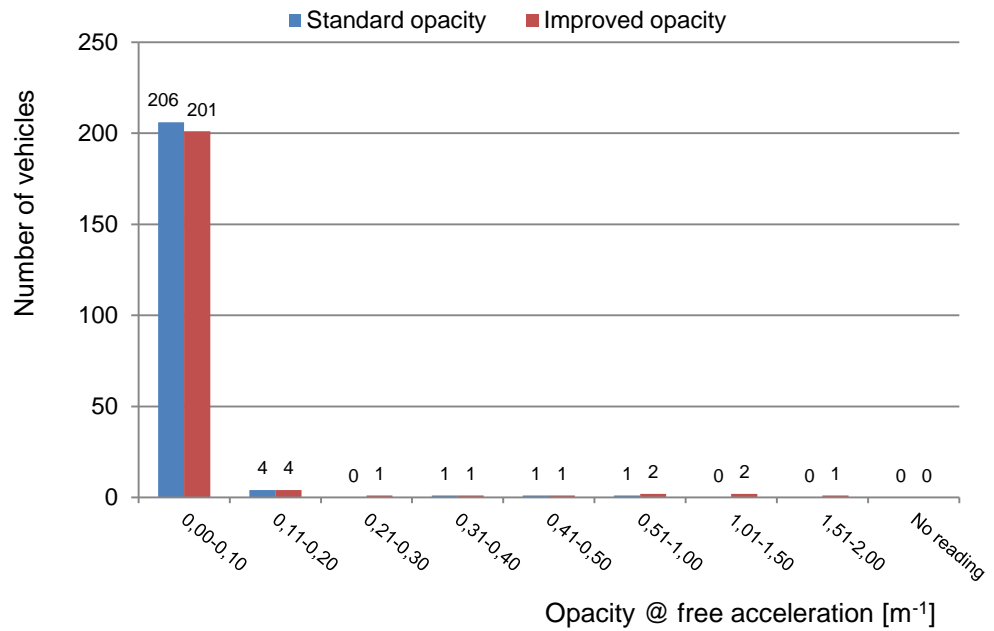
Figure 21 Standard and improved opacity test results.

Table 8 and Figure 21 show the test results of both opacity meters. Based on the standard opacity meter test results ("SO-EDA2" in the table), seven vehicles (3,3%) have an opacity of over  $0,10 \text{ m}^{-1}$ . Using the improved opacity meter, the opacity of twelve vehicles exceeds  $0,10 \text{ m}^{-1}$  (5,6%). In other words, based on these measurements 3,3 to 5,6% of tested vehicles have a malfunctioning or missing DPF; 94 to 96 percent of the tested vehicles has a well-functioning DPF.

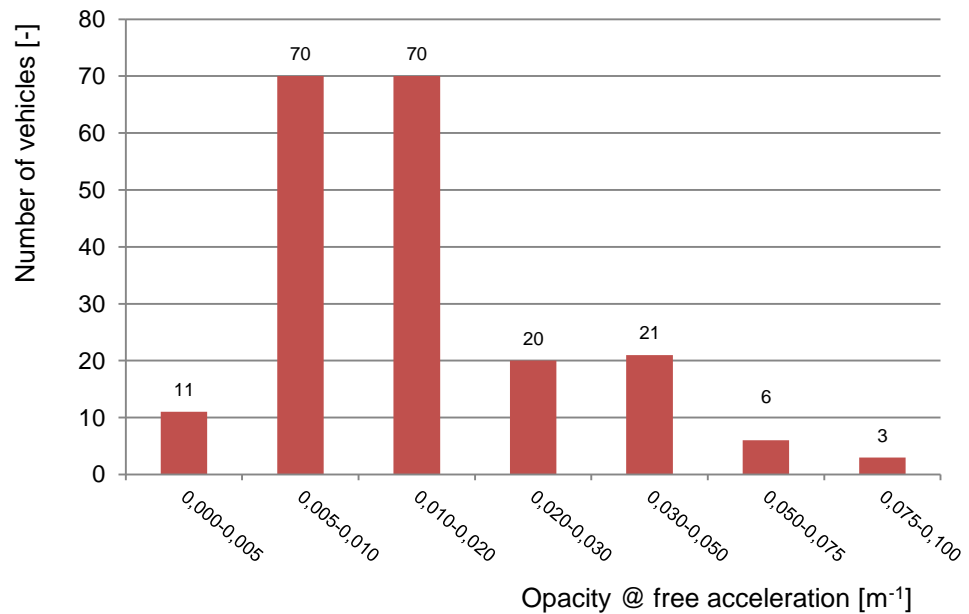
Figure 22 Further analysis of the 201 vehicles that do not exceed  $0,10 \text{ m}^{-1}$  using the improved opacity meter. 192 of those vehicles have an opacity not exceeding  $0,005 \text{ m}^{-1}$ , justifying a limit of  $0,10 \text{ m}^{-1}$ .

Taking a closer look at the 201 vehicles with an opacity not exceeding  $0,1 \text{ m}^{-1}$  yields Figure 22. As this figure illustrates, 192 of those 201 vehicles have an opacity not exceeding  $0,050 \text{ m}^{-1}$ . These test results indicate that modern diesel vehicles are well capable of reaching opacity values below  $0,050 \text{ m}^{-1}$ . In the course of the measurements,  $0,10 \text{ m}^{-1}$  was considered to be a relative high opacity. All this provides a basis for defining an opacity limit of  $0,10 \text{ m}^{-1}$  in future smoke measurements if applicable.

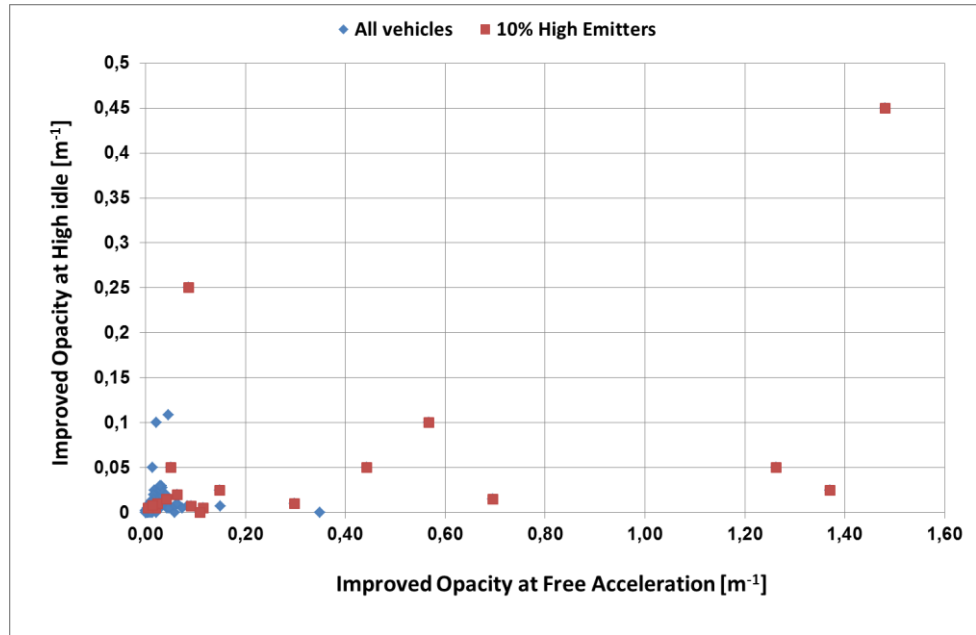
Figure 23 Improved opacity results in free acceleration and high idle speed tests.

Figure 23 plots free acceleration versus high idle speed smoke test results. No clear correlation between these two test types exists.

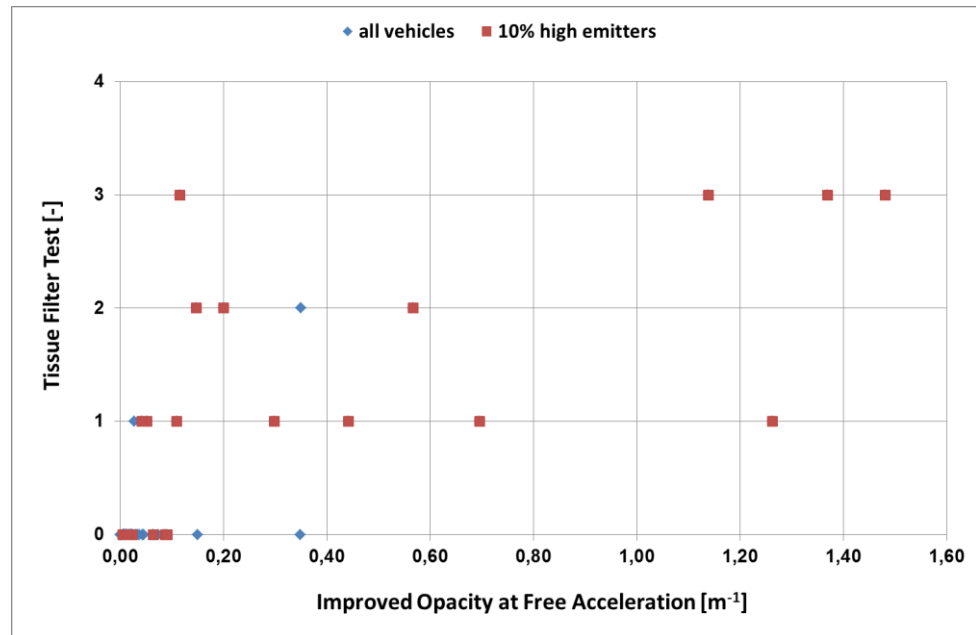
Figure 25 Improved opacity versus TFT results.

Opacity of the eight cars scoring 1 in the TFT ranged between 0,027 and 1,263 m<sup>-1</sup>. Five of those vehicles had an opacity of over 0,10 m<sup>-1</sup> in free acceleration. One car had PN emissions of 96,000 #/cm<sup>3</sup>; the other seven cars had an average PN emission of a little over 423,000 particles per cm<sup>3</sup>.

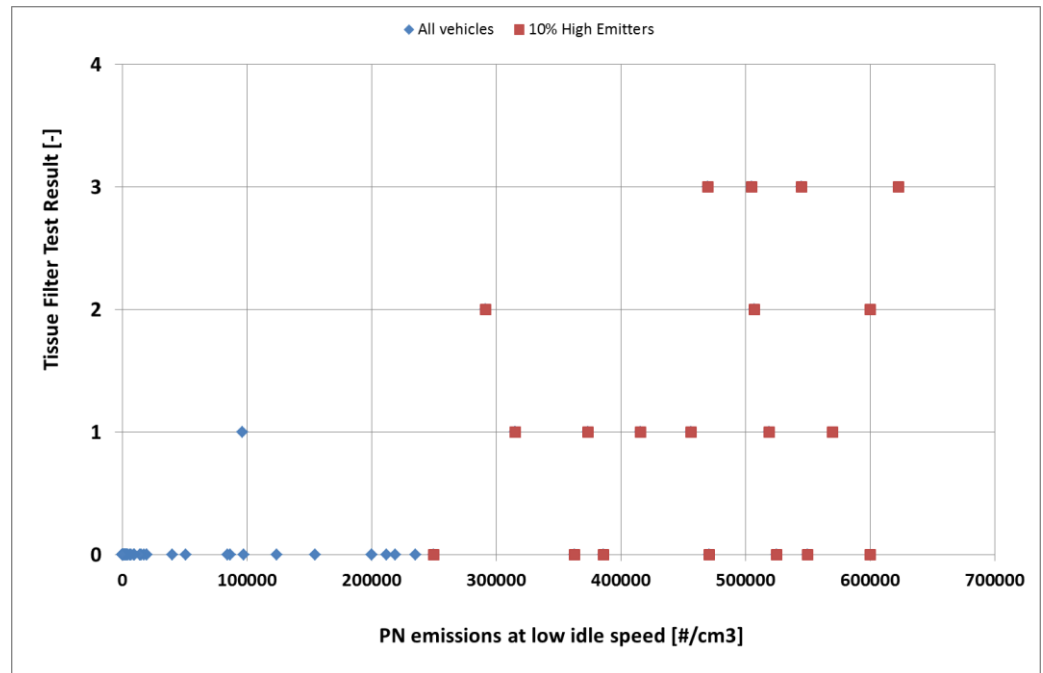
Figure 26 PN emissions versus TFT results.

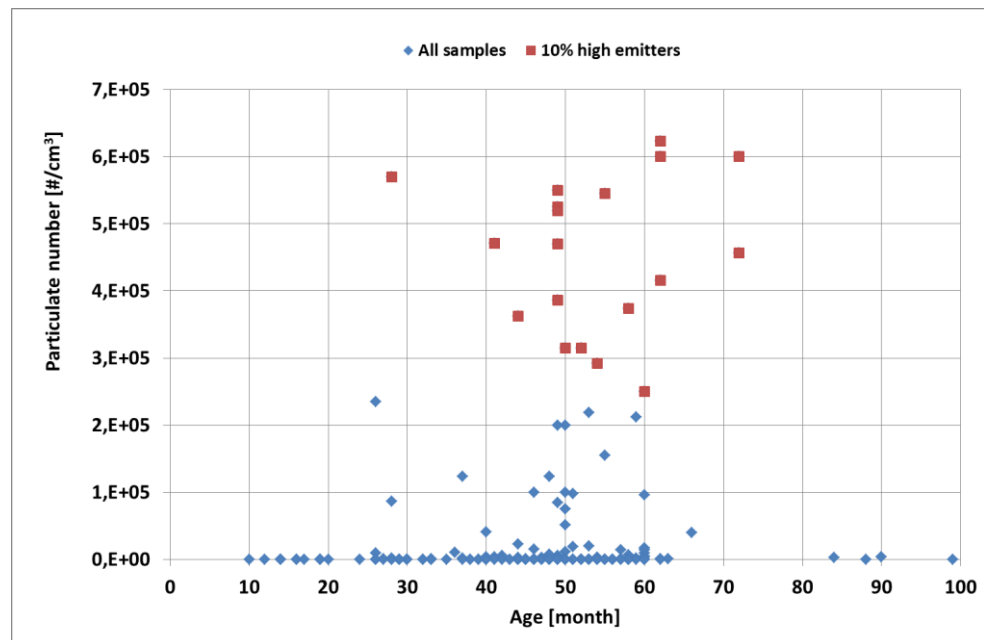
Figure 27: Particulate Number low idle speed test results of 213 vehicles.

Figure 27 shows the PN emission of 213 vehicles at low idle speed. The PN test results vary between 0 and 623,000  $\#/cm^3$  and have a relative good power of discernment variation over the measuring scale than opacity test results in a free acceleration test. It can be concluded that PN meters at low idle engine speed yield a relatively good screening performance.

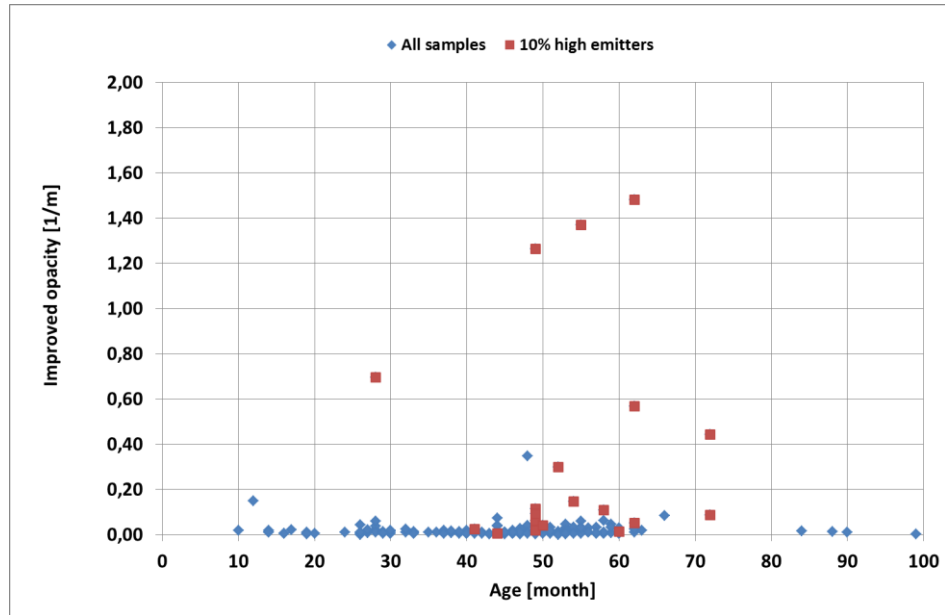
Figure 28: Improved opacity free acceleration test results of 213 vehicles.

In Figure 28 it is shown that the results of the improved opacity meter are less pronounced than the PN-results of Figure 27. This implies that PN-tests are more sensitive than smoke emission tests with an improved opacity meter and have a better screening performance.

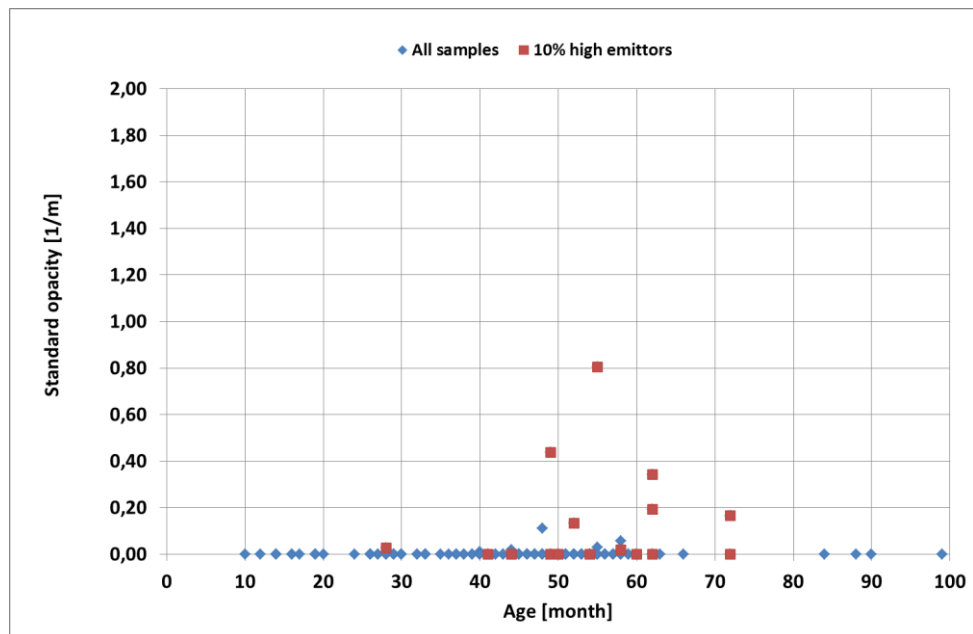
Figure 29: Standard opacity free acceleration test results of 213 vehicles.

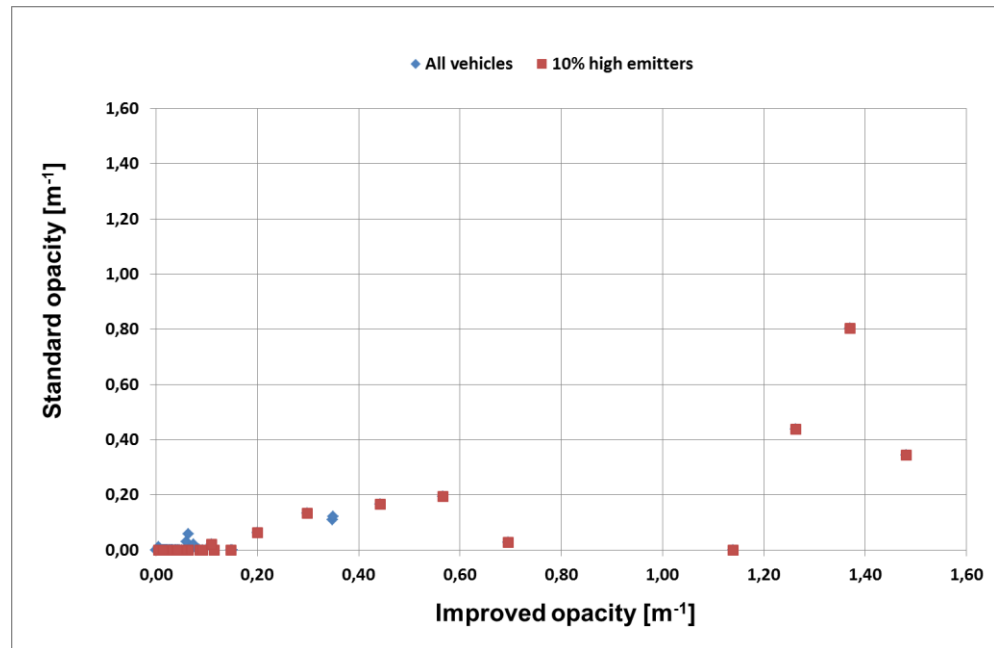
Figure 30: Relationship between improved and standard opacity free acceleration test results.

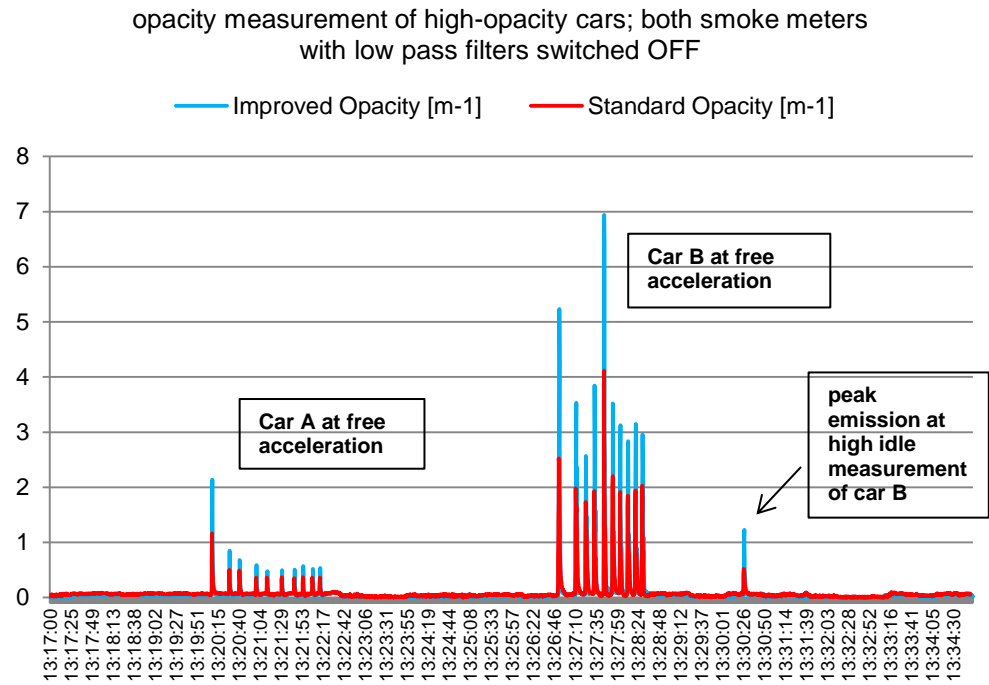
Figure 31 Results of opacity measurement of two cars with high smoke values, using the standard opacity meter and the improved opacity meter, both in the *unfiltered* mode.

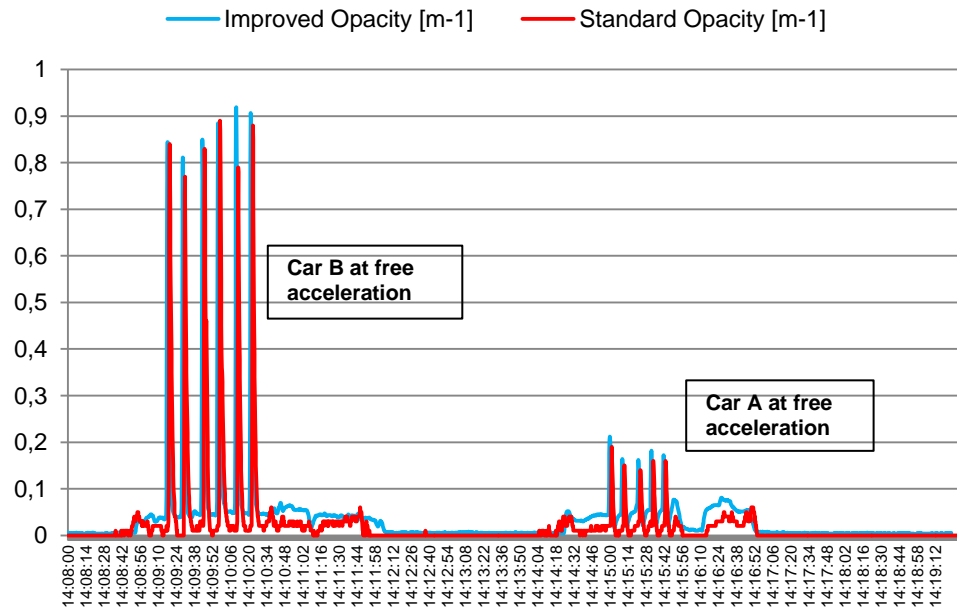
Figure 32 Results of opacity measurement of two cars with high smoke values, using the standard opacity meter and the improved opacity meter, both in the *filtered* mode.

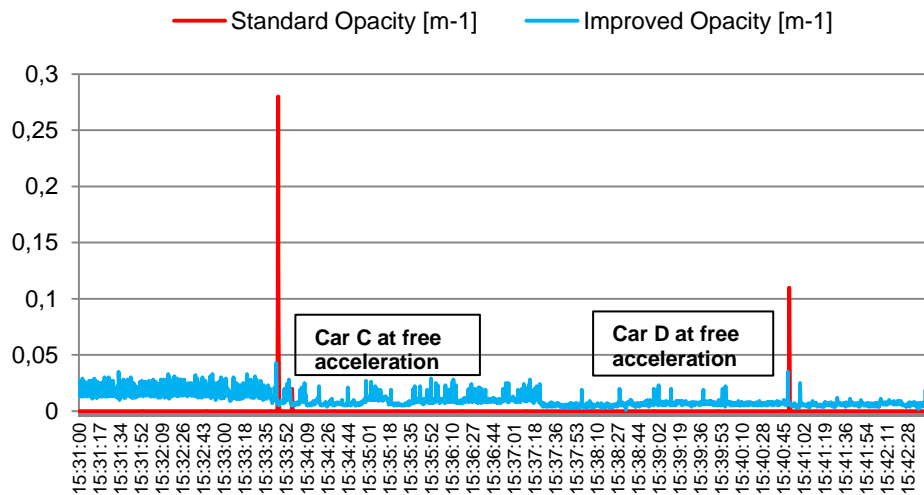
Figure 33 Results of opacity measurement of two cars with low smoke values, using the standard opacity meter and the improved opacity meter, both in the *unfiltered* mode.

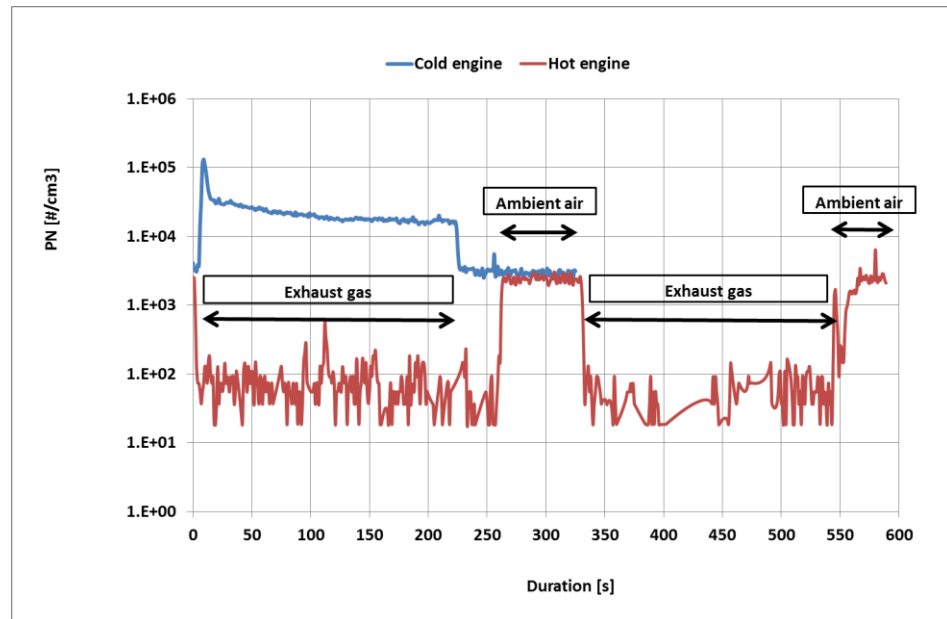
Figure 35 PN emissions of a euro 6 diesel vehicle with DPF at cold and hot engine operation.

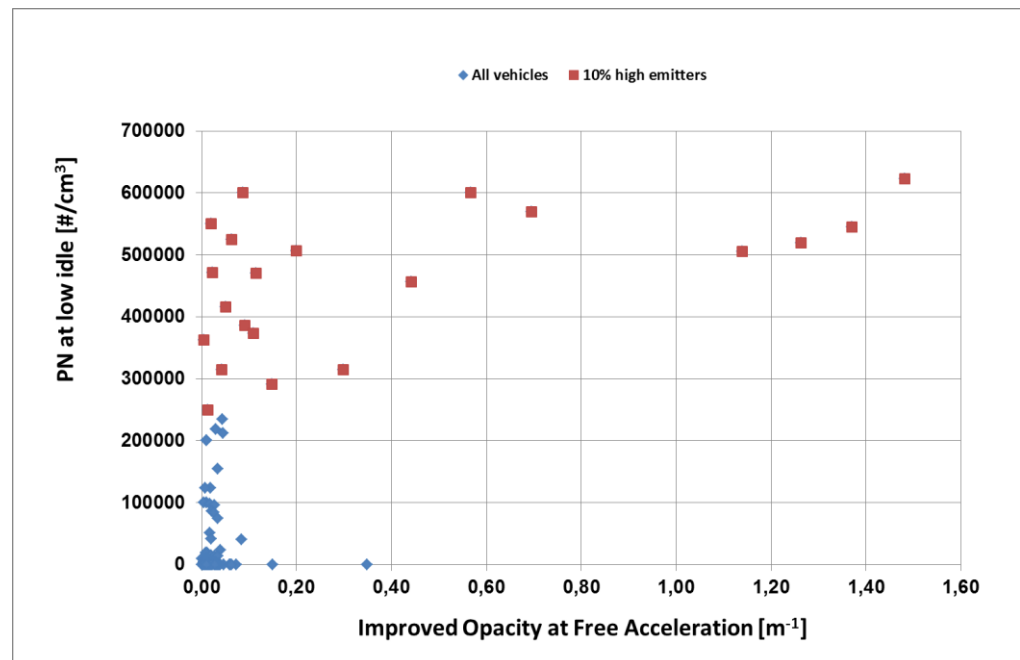
Figure 36: Relation between improved opacity in FA-tests and PN emission at low idle speed.

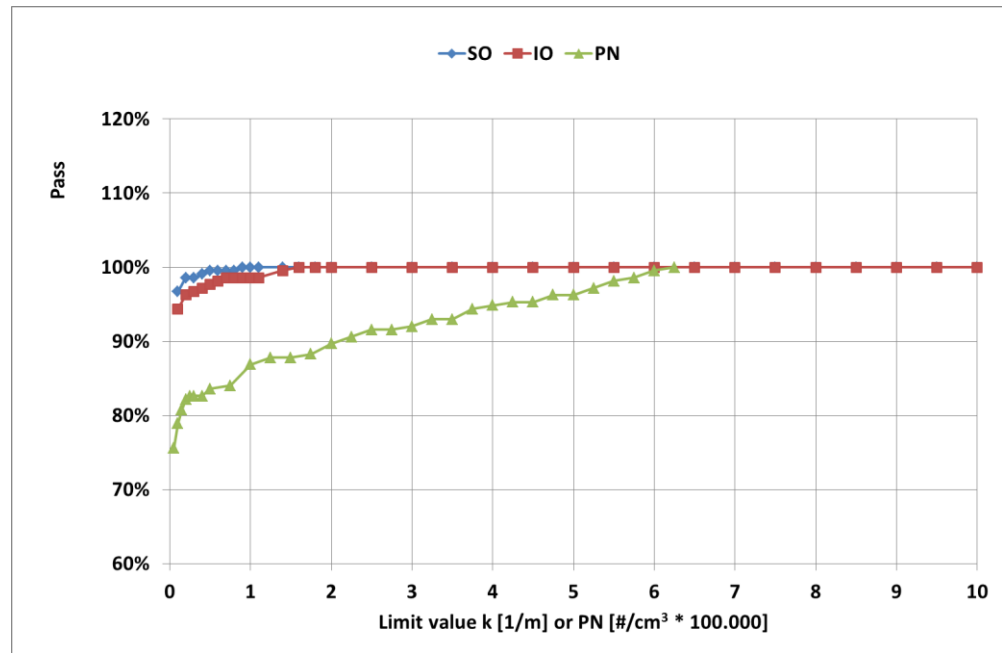
Figure 37: Relation of percentage of passed opacity and PN tests and limit values

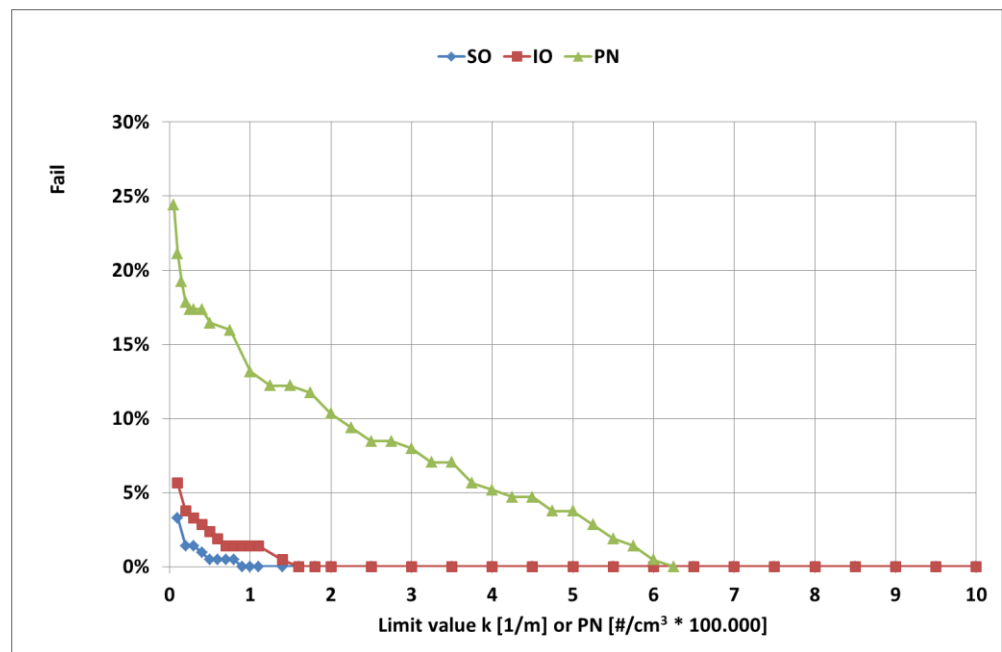
Figure 38: Relation of percentage of failed opacity and PN tests and limit values

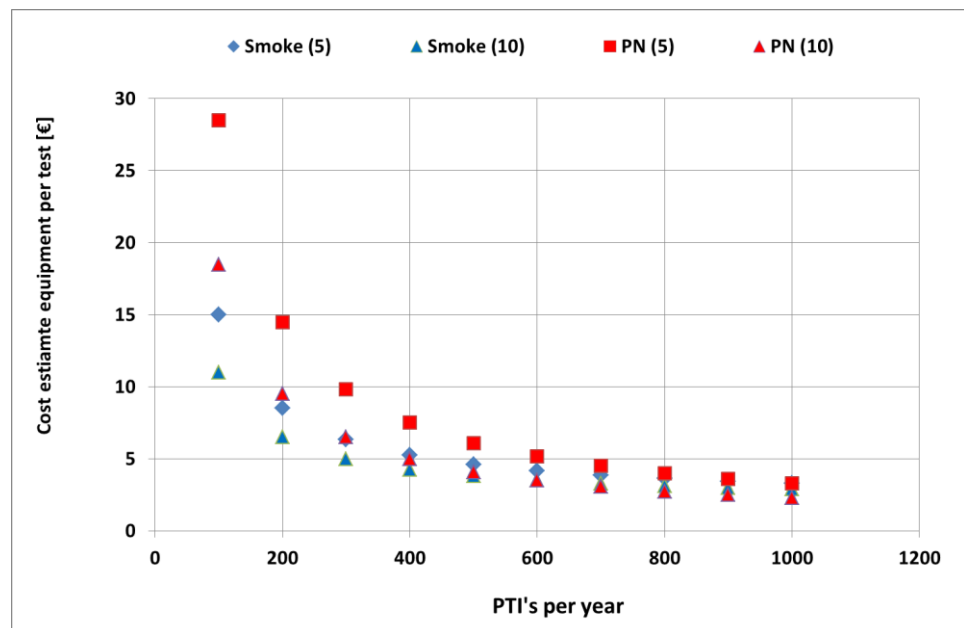
Figure 41 Cost estimate of single PTI DPF tests with smoke or PN meters with economic lifetimes of test equipment of 5 and 10 years.

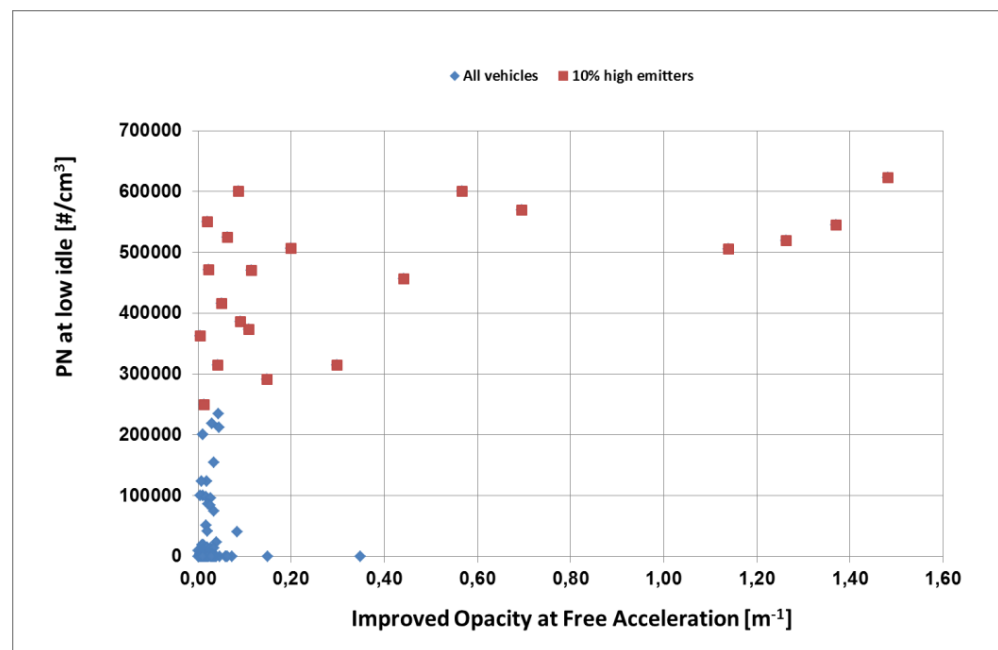
Figure 42: Relation of improved opacity in FA-tests and PN emission at low idle speed
